**Surface Water Assessments in Centre County Pennsylvania:
The Beech Creek Watershed**

Healthy Waters #4100059330

Centre County Conservation District

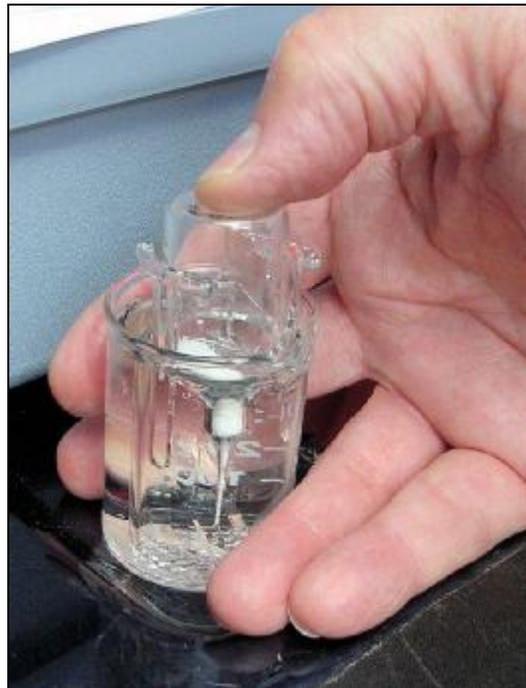
In-stream water quality was evaluated in the field on the day of sampling for each of the nine sample sites. A 1000mL plastic bottle was filled with water from the sample site. The bottle was flushed three times in the stream prior to the sample being taken. All field measurements were taken from this sample immediately after the sample was taken. An Oakton multi-parameter Tester 35 (model: PCSTestr35) was used to measure the air and water temperature, pH, EC, total dissolved solids (TDS), and salinity. The meter was calibrated for pH and electrical conductivity prior to each sampling event. A standard U.S. 3 point calibration was applied with unexpired Hach or Oakton buffer solutions of 4.01, 7.0, & 10.01 pH. A single point EC calibration was also completed with either Hach or Oakton 1500uS/cm or 1413uS/cm standard solutions prior to each sampling event. This meter also contains a digital thermometer which was calibrated at the beginning of the year with a reliable fishing thermometer. A Hach Colorimeter (model: DR/850) was used solely for dissolved oxygen (DO) measurements. DO measurements were taken at streamside due to the sensitivity of this measurement to temperature. This measurement process requires a vacuum sealed, glass ampul which contains reagents that react with the water drawn into it by the vacuum (Figure 6). After some time and agitation, the water is discolored such that it can be interpreted by the instrument as a DO level. Care was taken to keep the tube containing each stream's water sample free of condensation or

smudges, since it was used to zero the meter. Also the reading chamber and ampul were consistently wiped clean with Q-tips and a cloth to ensure accuracy. In addition, comparisons of DO measurements were made where the ampul was submerged directly into the stream, versus those done on a bottled stream sample as mentioned above. Little difference was found in the results. For either method, the colorimeter cannot be placed in the water, and the ampul would be exposed to ambient air temperature when shaking. The air & water temperature were taken with the Oakton meter almost concurrently with the DO measurement, since a different meter was used. DO results were not compensated for temperature or altitude. These measurements were closely followed by EC, TDS, salinity, and pH in that order.

Figure 6: Photograph of the glass ampule used to obtain dissolved oxygen measurements.

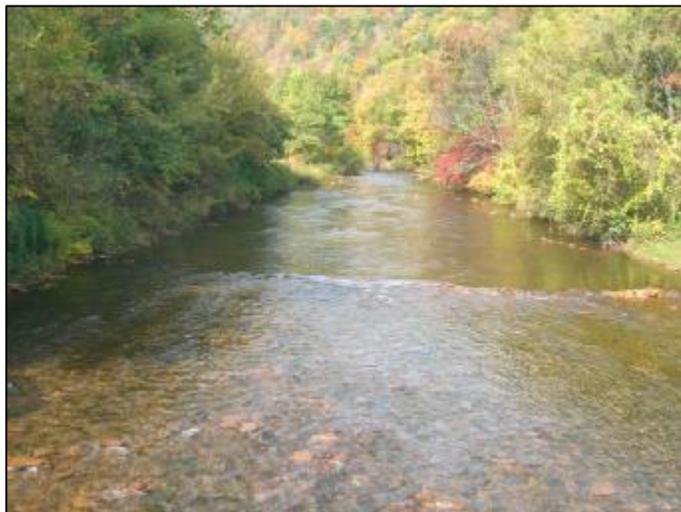
- *Beech Creek*: The sample site on the main stem of Beech Creek is located just above the dilapidated bridge and just outside the channel created by Monument Run in the town of Monument. AMD impairs the main stem of Beech Creek and the water is red in color due to iron precipitate.

Water quality results from the field surveys are summarized in Table 4. The only parameter that violated Chapter 93 water quality standards was pH at the sample site on Beech Creek in Monument. The dissolved oxygen was adequate in each of the samples to support biological life in a cold water environment. With the exception of the Beech Creek site (Figure 8), which is polluted by AMD, the conductivities were characteristic of the area.

Figure 8: Sample site on the mainstem of Beech Creek at Monument.

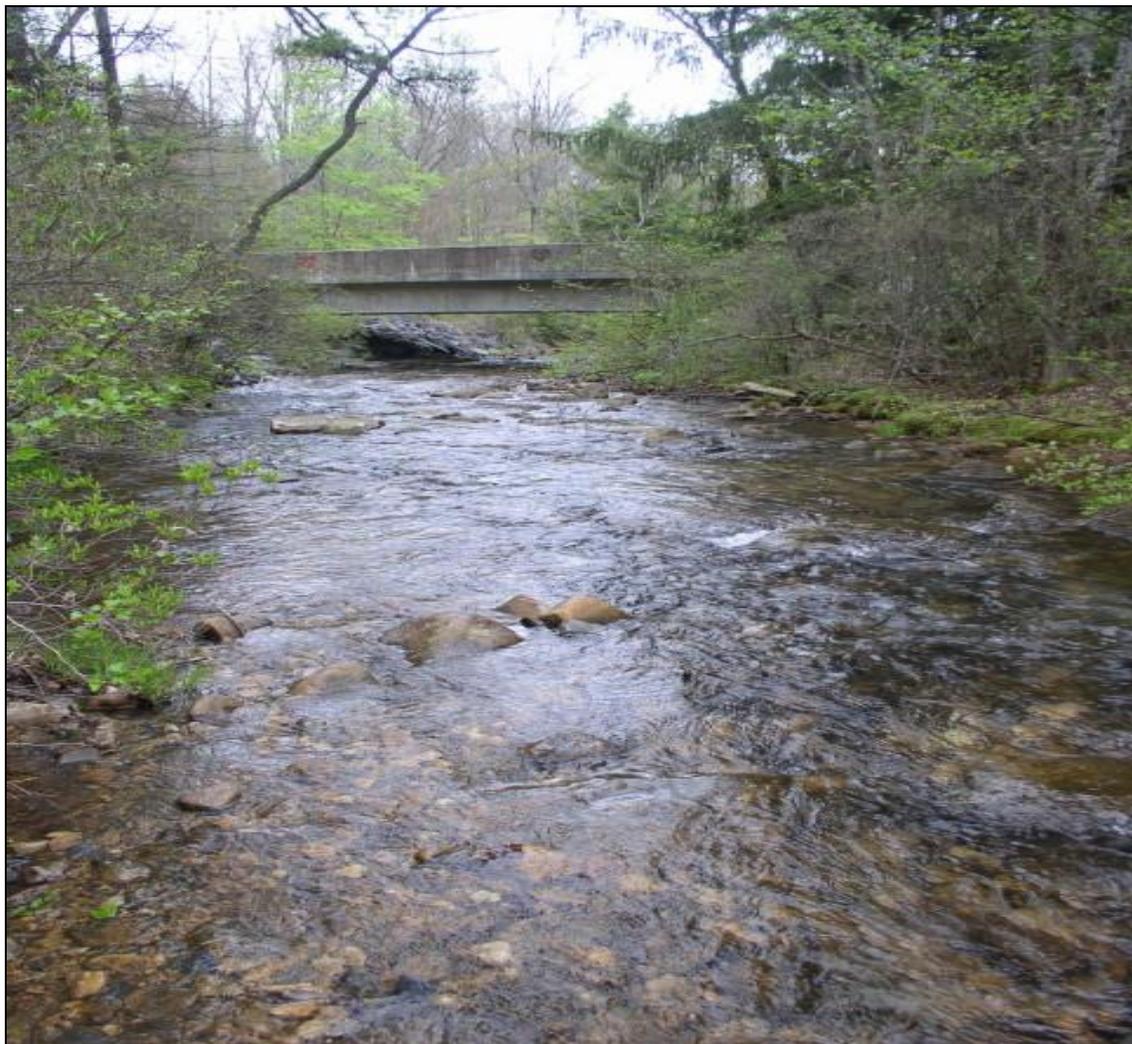
The survey site on Wolf Run at Panther Road (Figure 9) received a total habitat score of 220 out of a possible 240, which places the habitat at this location in the optimal category. The site received optimal scores for 11 of the 12 parameters. The site received a suboptimal score for channel alteration due to the presence of a bridge crossing on Panther Road. Habitat does not appear to be a limiting factor for aquatic life in this section of Wolf Run.

Figure 9: Sample site on Wolf Run at Panther Road bridge crossing.

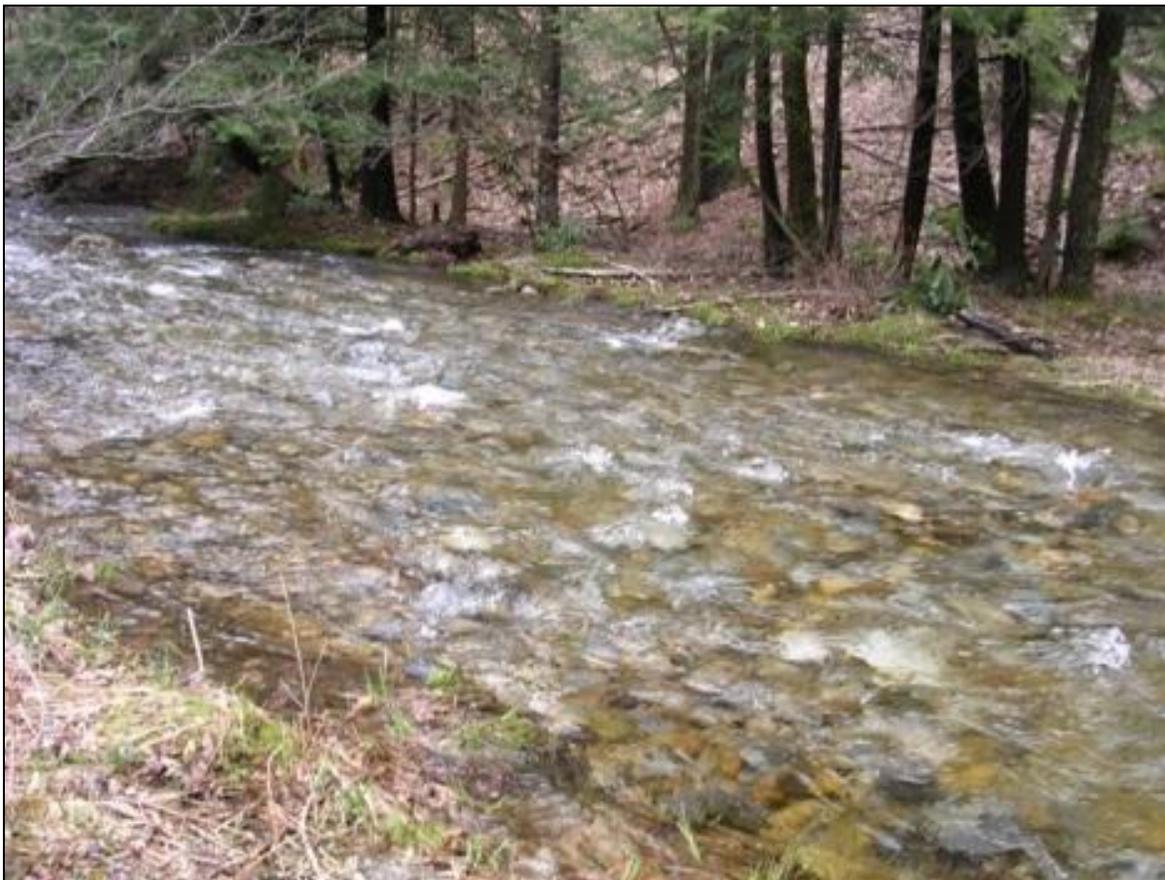
The survey site on Wolf Run at State Line Road (Figure 10) is located upstream of the Wolf Run site at Panther Road. At this location, the site received a total habitat score of 216 out of a possible 240, which places the habitat at this location in the optimal category. The site scored within the optimal range for all parameters with the exception of embeddedness, velocity/depth regimes, and channel alteration. The lower scores for these parameters were primarily due the bridge crossing located upstream of the survey site. The bridge crossing has caused some channel alteration and some sediment deposition on the stream's substrate (embeddedness). In addition, the site lacked deep pool habitat, which is crucial for several life stages of brook trout. It appeared that habitat did improve upstream and downstream of the bridge's influence. However, habitat in these areas was not evaluated.

Figure 10: Sample site on Wolf Run at State Line Road.

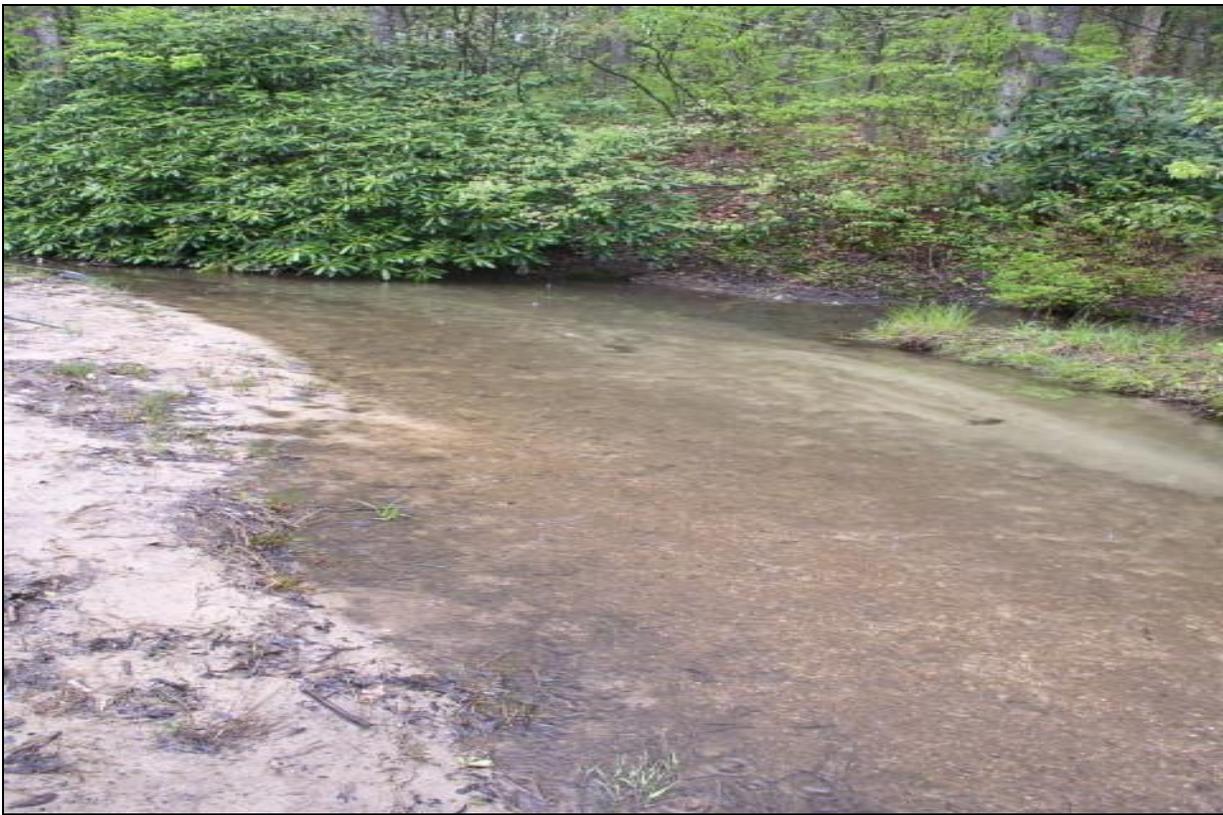
The survey site on Little Sandy Run (Figure 11) was located just upstream of the Three Point Sportsman fish hatchery. The habitat at this site received a total score of 152 out of a possible 240, which placed the habitat at this location in the suboptimal category. The major habitat issue at this site is a small impoundment. The impoundment is causing increased sediment deposition and embeddedness as well as creating a large pool that lacks riffle habitat. In addition, very little riparian buffer exists in this area of the stream, adding to erosion and sedimentation issues. Habitat is likely a limiting factor for aquatic life in this section of Little Sandy Run.

Figure 11: Sample site on Little Sandy Run. The site was located upstream of the Three Points Sportsman’s fish hatchery.

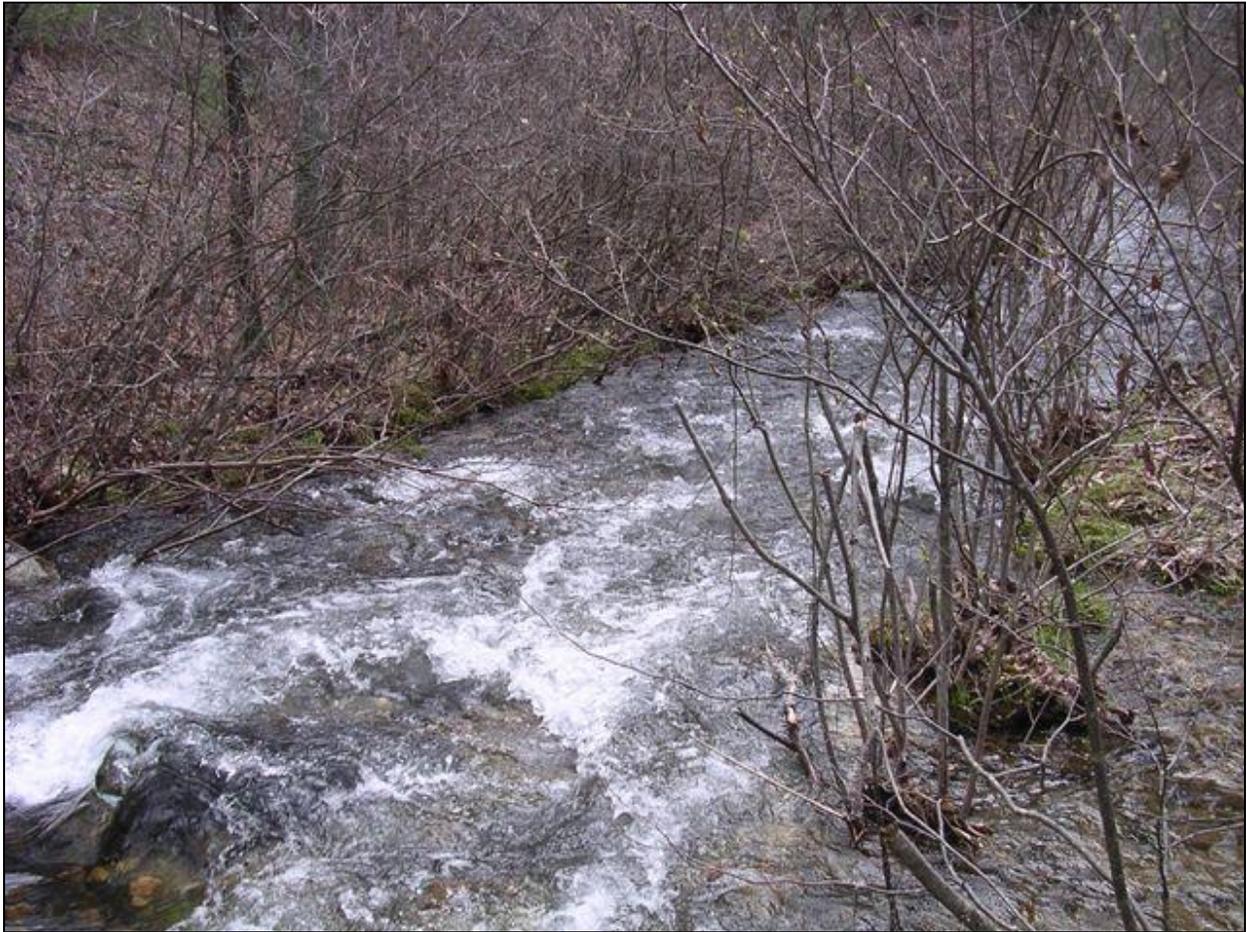
The survey site on Panther Run (Figure 12) received an optimal total habitat score (231 out of 240). The survey site was located in a remote location that was completely forested. The site received optimal scores for each of the 12 habitat parameters evaluated. It is unlikely that habitat is a limiting factor for aquatic life on Panther Run.

Figure 12: Sample site on Panther Run.

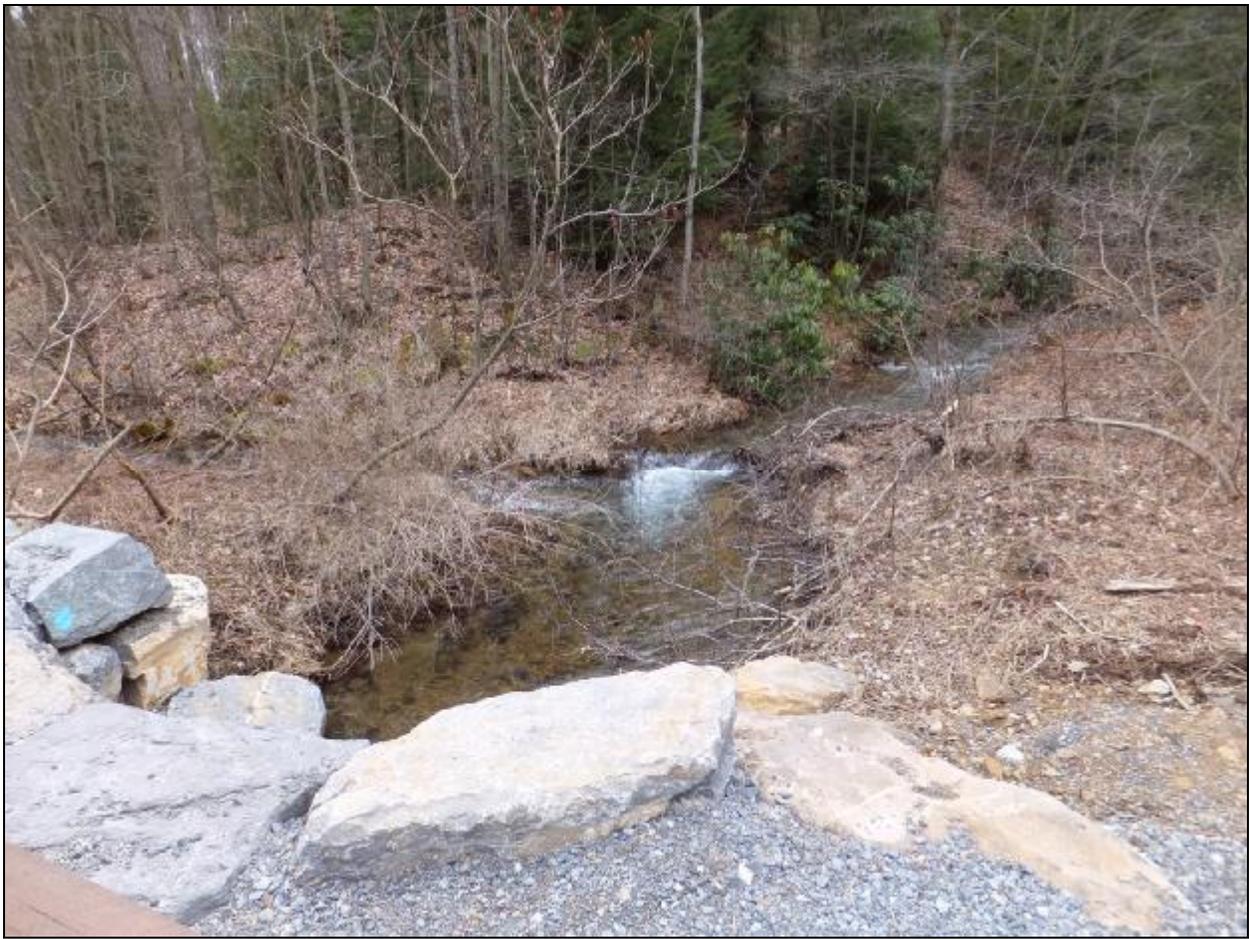
Just upstream of the survey site on Council Run, an unnamed tributary enters Council Run. The survey site was located at the mouth of the unnamed tributary (Figure 14). The official number of the tributary is UNT 22700, according to PA DEP. This survey site received a total habitat score of 175 out of a possible 240, which placed the habitat at this location in the suboptimal category. The site lacked significant pool habitat. In addition, a dirt and gravel road located along the stream's right bank has had a significant influence on the habitat quality of the stream in this location. The presence of the road has caused some channel alteration and removed a large portion of the riparian buffer along the right bank of the stream.

Figure 14: Sample site at the mouth of UNT 22700. The UNT can be seen entering Council Run on the left.

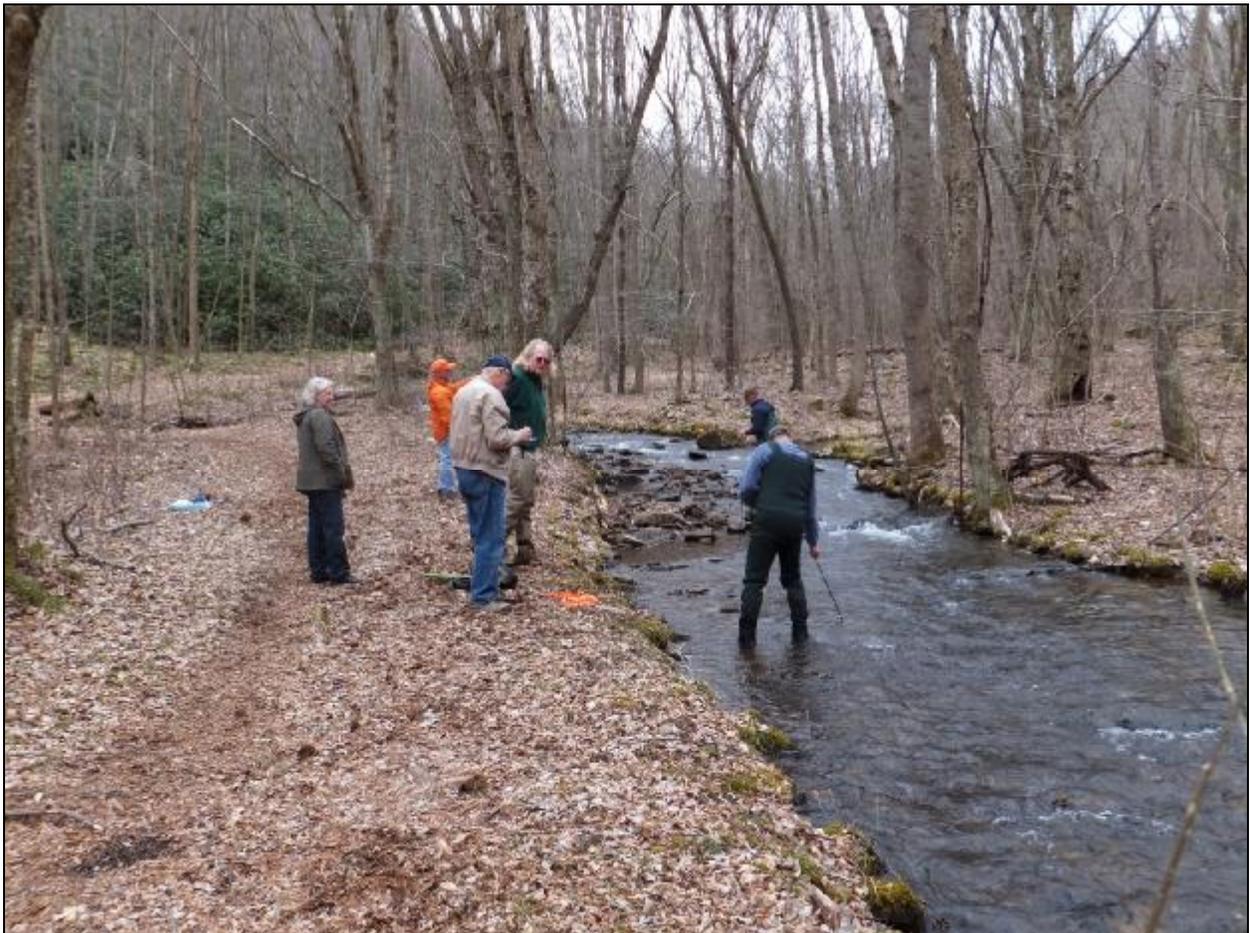
The survey site on Hayes Run (Figure 15) received a total habitat score of 220 out of a possible 240, which placed the habitat at this location in the optimal category. The site received optimal scores for 11 of the 13 parameters. The site received a suboptimal score for bank vegetative protection because of a mowed path that is parallel to the stream in this location. Overall, habitat does not appear to be a limiting factor for aquatic life in this section of Hayes Run.

Figure 15: Sample site on Hayes Run.
